Suspended timber ground floors: Heat loss reduction potential of insulation interventions

S. Pelsmakers^{a,*}, C.A. Elwell^b

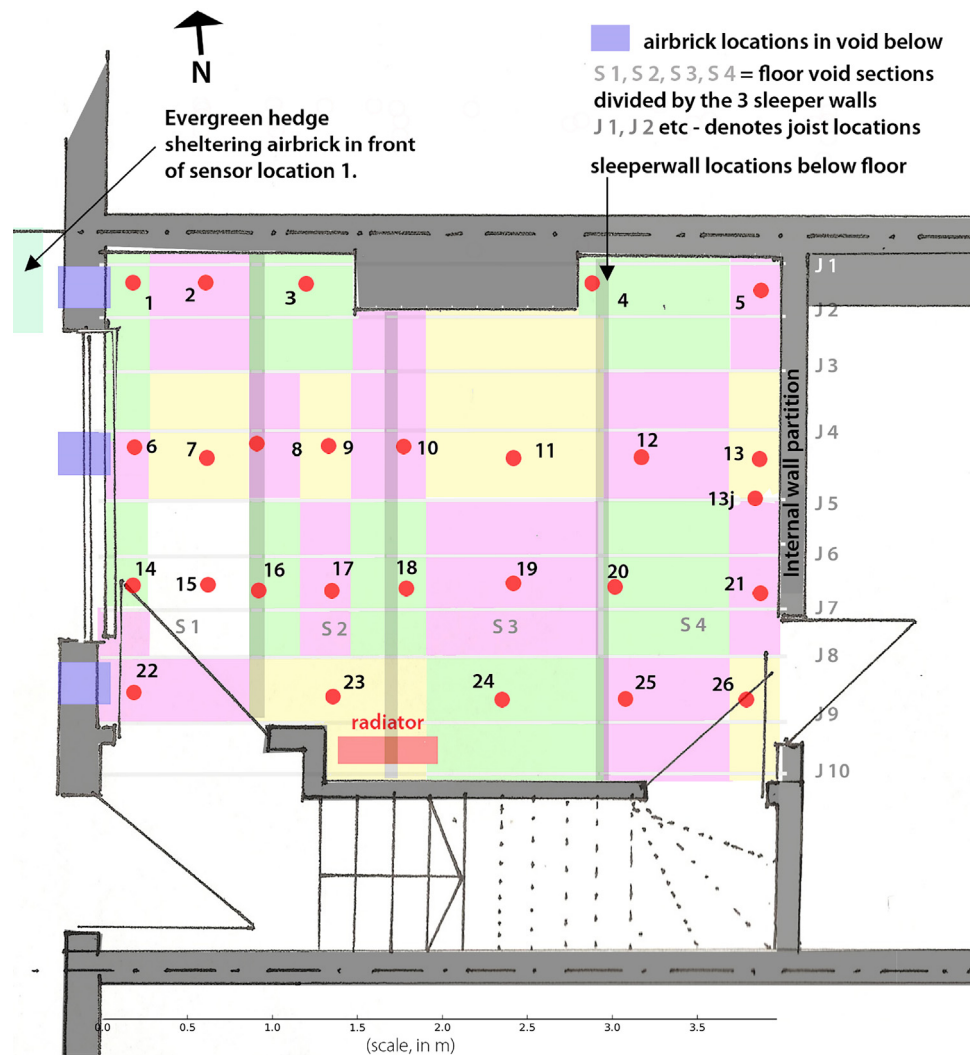
Fig. 1. Floor plan with heat flux sensor locations (red circles and numbered); airbrick locations (blue), and sleeper walls (grey). Approximate joist locations are marked with a faint grey line and annotated with J1, J2 etc. Location 13j is the only location measured on a joist. Portable radiant oil-filled electrical plug-in heaters are marked on the plan. Note that the colours have no meaning other than each colour distinguishes one representative area around a HF sensor from another. Representative areas were derived from infrared images. (For interpretation of the references to colour in this figure legend, the reader is referred to the web version of this article.)

An area weighted U-value (U_{wf}) was obtained by defining areas (as shown in Fig. 1) around each heat flux sensor for the uninsulated floor, for which its measured per unit area heat flux was considered the most representative available. This was achieved by detailed

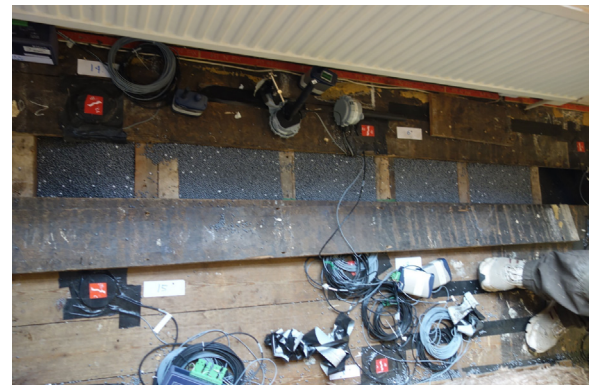
Fig. 2. The bead filled floor along the exposed perimeter wall.

Loose graphite coated EPS beads ($\lambda = 0.033 \text{ Wm}^{-1} \text{ K}^{-1}$ [50]) were blown into the full depth of the four floor void sections, allowing the insulation of floors without the disruption of lifting and re-fitting all of the floorboards. As the entire floor void depth is filled with EPS beads, and to avoid beads spilling out, airbricks were sealed with airtightness tape and covered with waterproof plastic boxes on the outside and bubble wrap on the inside. However this is yet to be proven appropriate, as airbricks are in place to regulate moisture in the void [51–53]; the long-term impact of sealing airbricks remains uncharacterised at present. Four floorboards – one in each section – were lifted to fill the entire 250 mm floor void under the joists and in between and up to the top of the 100 mm joist height, using the same equipment as cavity blown EPS beaded insulation, without the binding agent to allow for later removal of the beads by vacuuming them out. After mechanical filing, beads were manually filled and smoothed to the top of the joists – see Figs. 2 and 3.

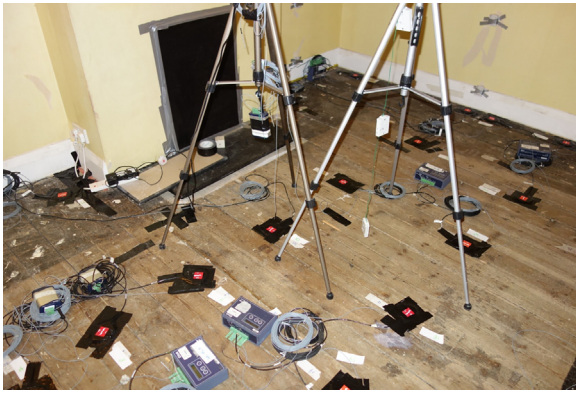
Fig. 3. Post-bead insulation with monitoring instruments in place.

After bead removal,² all instruments and floorboards (as illustrated in Fig. 3) were removed and 100 mm woodfibre insulation

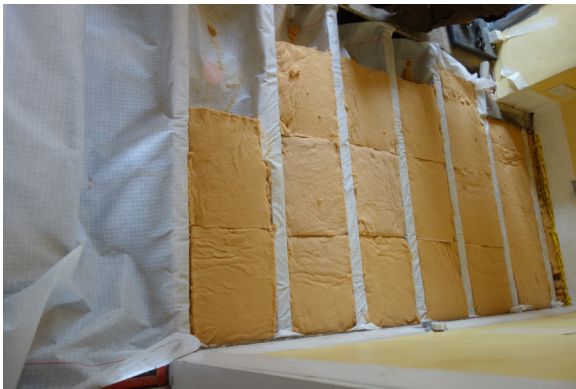
Fig. 4. Installation of woodfibre insulation in between the joists, held in a breather membrane over and under joists.

($\lambda=0.038 \text{ Wm}^{-1} \text{ K}^{-1}$ [54]) was installed between the joists (see Fig. 4), held by a tightly stretched and stapled breather membrane suspended over and under the joists with taping of overlapping joints. This is a typical insulation solution, but generally the insulation is a more flexible product such as mineral wool, which can be more easily inserted between unevenly spaced floor joists and often installed DIY [55,56] and held in place by netting. Reduced insulation had to be fitted where radiator pipes and services encroached in the space between joists, as was the case near sensor locations 23–26. Near the airbricks, the insulation was also reduced by chamfering the edge to allow airflow underneath (see Fig. 5). Insulation was fitted tightly between the joists to minimise any air gaps which could lead to increased convective heat loss [57]. The airflow between sleeper wall sections was likely significantly reduced due to the insulation being installed between joists, which were the largest openings between floor void sections prior to insulation (see Fig. 6).

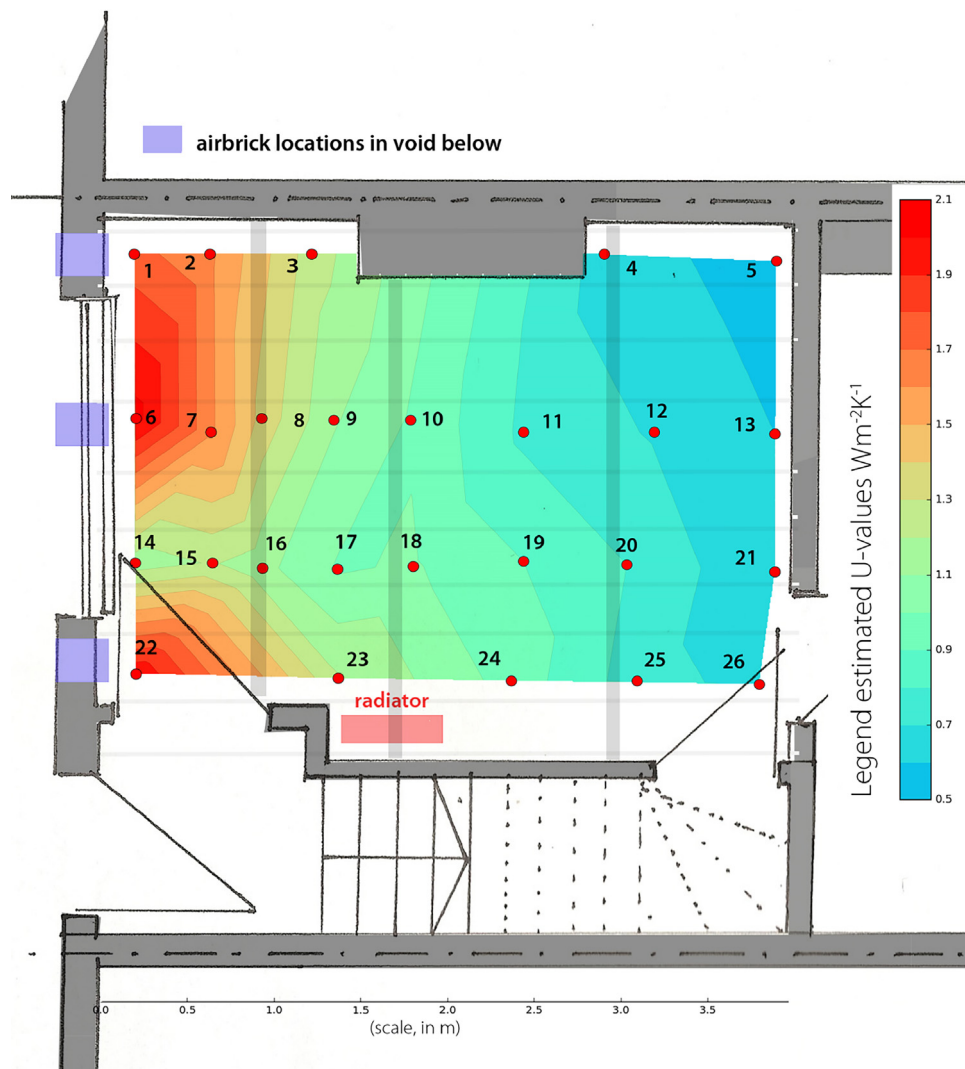
Fig. 7. Presents linearly interpolated U_p -values as a heat map between observed point U -value locations for the uninsulated floor; point locations are marked with a round dot and numbers; sleeper wall locations are indicated in light grey shade. Note that the map only shows interpolated values between points, with no values between the walls and the points (hence the white zone). Joist presence is not accounted for.

For the uninsulated floor, there is a clear association between the measured U_p -value and distance to the external perimeter walls [38,58], see Fig. 7. However, the relationship between the distance from the observed location to the exposed wall was significantly

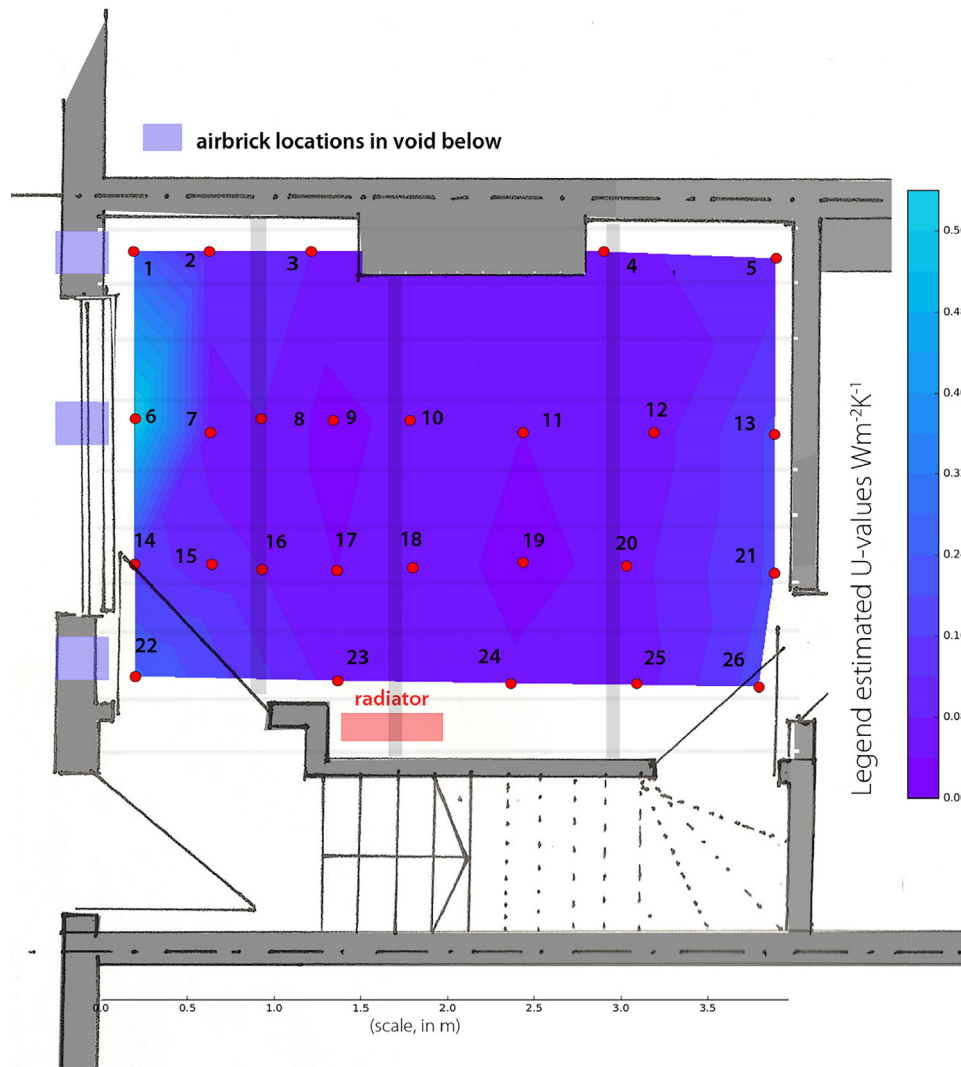
Fig. 8. Linearly interpolated U_p -values as a heat map between observed point U -value locations for the bead insulated floor, with the same scale used for the colour legend as in Fig. 7. An overall significantly reduced heat loss is observed post-insulation, with a reduced perimeter effect (though still present) and a more even spread of U_p -values across the floor.

reduced once insulated, though there were still increased U_p -values in the perimeter zone – see Figs. 8 and 9. U_p -values near the perimeter were considerably lower for the bead insulated floor compared to the uninsulated floor, explained by the sealed airbricks and large amount of insulation – see Fig. 8. However, as illustrated in Fig. 9, for the woodfibre insulated floor, a larger perimeter effect was still observed due to insulation installation quality issues, as described in section 4.3. Due to this, only small heat-flow reductions were observed in locations 6 and 14 near the exposed perimeter, while an increase in U_p -value was observed in location 21 further away from the perimeter and only a small reduction in location 3 (all were within the margins of error) – see Table 3 and section 4.3.

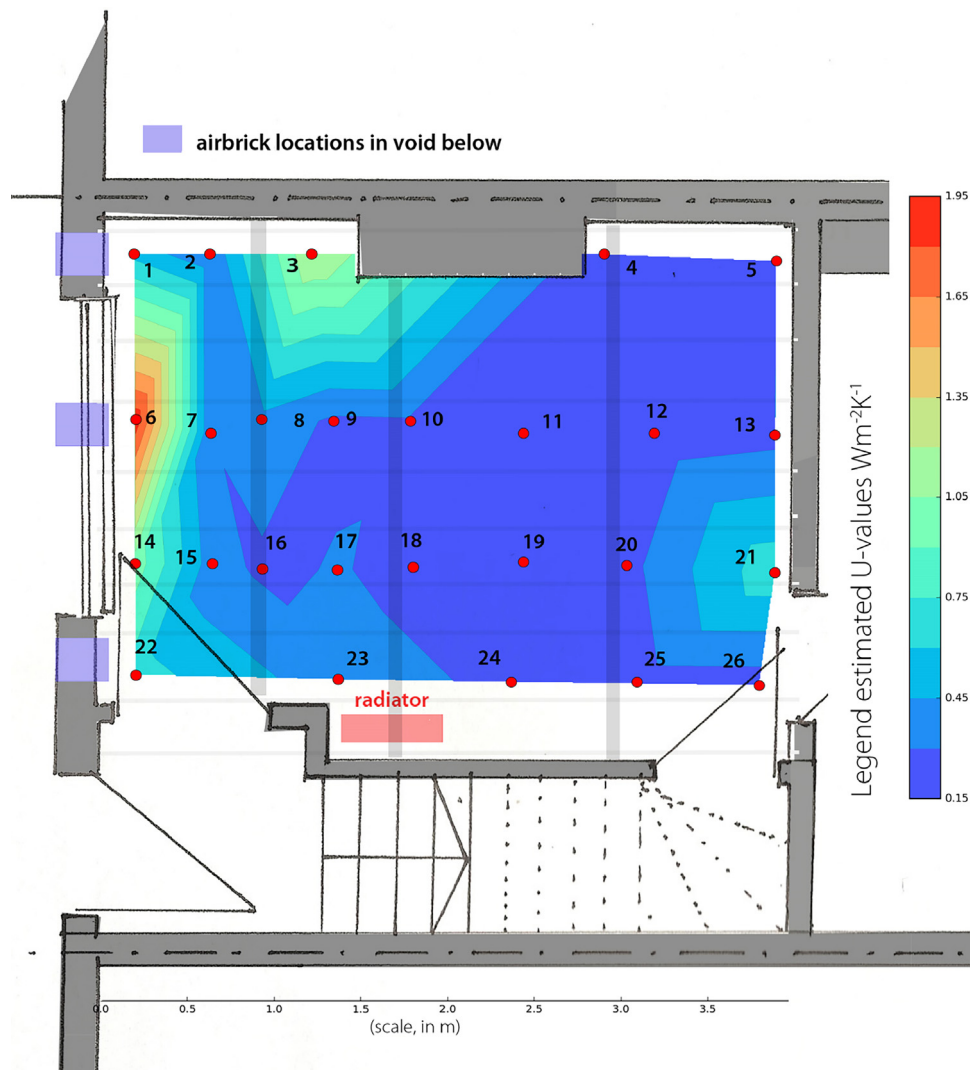
Fig. 9. Linearly interpolated U_p -values as a heat map between observed point U -value locations for the woodfibre insulated floor with the same scale used for the colour legend as in Figs. 7 and 8. An overall significantly reduced heat loss is observed post-insulation, though as expected not as much as the bead-insulated floor. There is still a significant perimeter effect and also a large spread of U_p -values across the floor.

cially pronounced for the woodfibre insulated floor, due to the significant spread of U_p -values across the floor (see Fig. 9).

Generally, U_p -values for the woodfibre insulated floor were between 58%–81% lower than the uninsulated values, depending on where measurements were taken (see Table 3). Use of the thermal camera, combined with the high-resolution measuring technique and post-measurement lifting of floorboards to visually assess the installation fit and quality, allowed for the identification of local installation issues, caused by insufficiently tight-fitting insulation in some areas. For example, insulation in locations 6 and 14 was ill-fitting against the perimeter foundation wall, in addition to reduced insulation from chamfered edges in location 6 (see Fig. 5), leading to reduced heat loss savings post-insulation – see Fig. 9 and

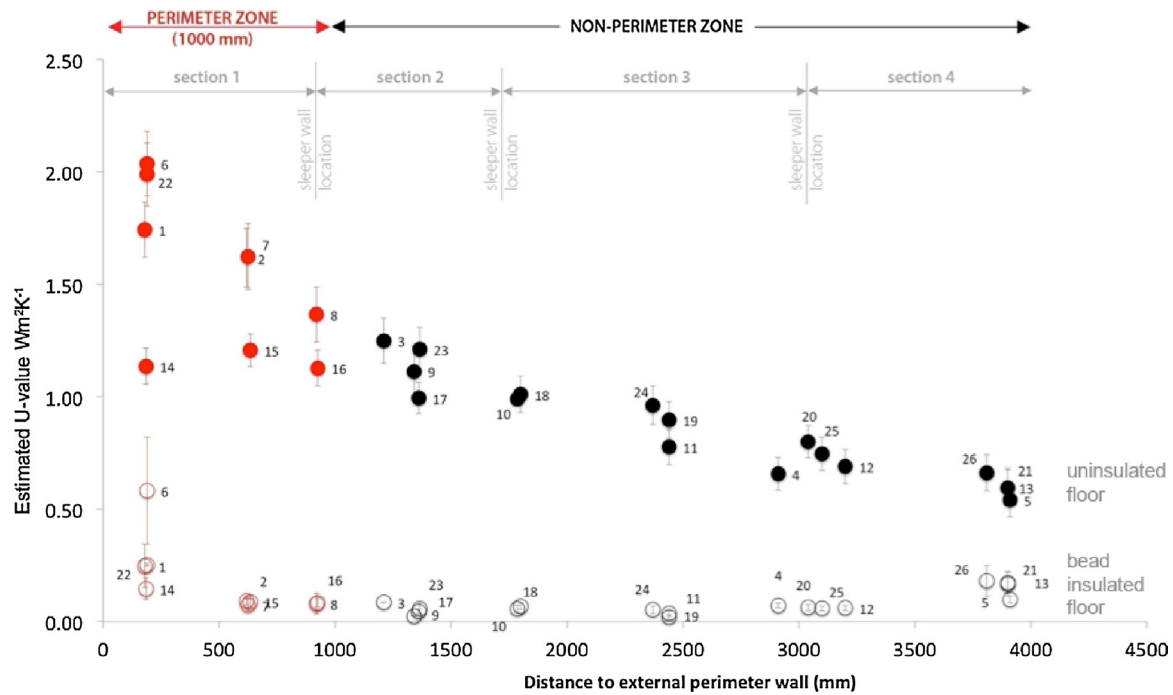
U_p -values (outline data points) as a function of distance to the exposed wall. Red data points are located in the 1000 mm perimeter zone; black data points are $>1000 \text{ mm}$ away from the external perimeter wall. Error margins are as per Eq (3); pre/post insulated point U -values are outside the estimated margins of error. Significant U_p -value reductions are observed after insulation.

Fig. 10. Plots the uninsulated U_p -values (solid data points) compared to bead-insulated U_p -values (outline data points) as a function of distance to the exposed wall. Red data points are located in the 1000 mm perimeter zone; black-data points are > 1000 mm away from the external perimeter wall. Error margins are as per Eq. (3); pre/post insulated point U -values are outside the estimated margins of error. Significant U_p -value reductions are observed after insulation. (For interpretation of the references to colour in this figure legend, the reader is referred to the web version of this article.)

The increased U_p -values in the perimeter zone were statistically significant for both insulated floors (Mann–Whitney ($W = 127$, $n_1 = 9$; $n_2 = 17$, $P < 0.05$ (0.005, unpaired)) for the bead insulated floor and Mann–Whitney ($W = 130$, $n_1 = 9$; $n_2 = 17$, $P < 0.05$ (0.003, unpaired)) for the woodfibre insulated floor). For the bead insulated floor, the estimated mean of the perimeter U -values was $0.18 \pm 0.08 \text{ Wm}^{-2} \text{ K}^{-1}$ compared to $0.08 \pm 0.02 \text{ Wm}^{-2} \text{ K}^{-1}$ for locations $>1000 \text{ mm}$ away from the perimeter (after [58]). For the woodfibre insulated floor, the mean perimeter zone U -value was $0.64 \pm 0.11 \text{ Wm}^{-2} \text{ K}^{-1}$ compared to $0.33 \pm 0.06 \text{ Wm}^{-2} \text{ K}^{-1}$ in the non-perimeter zone. In both cases, locations near the airbricks (sealed for the bead intervention) were generally outside the margins of error of other estimated point U -values and the pre/post U_p -values were also generally outside the estimated margins of error (see Figs. 10 and 11).

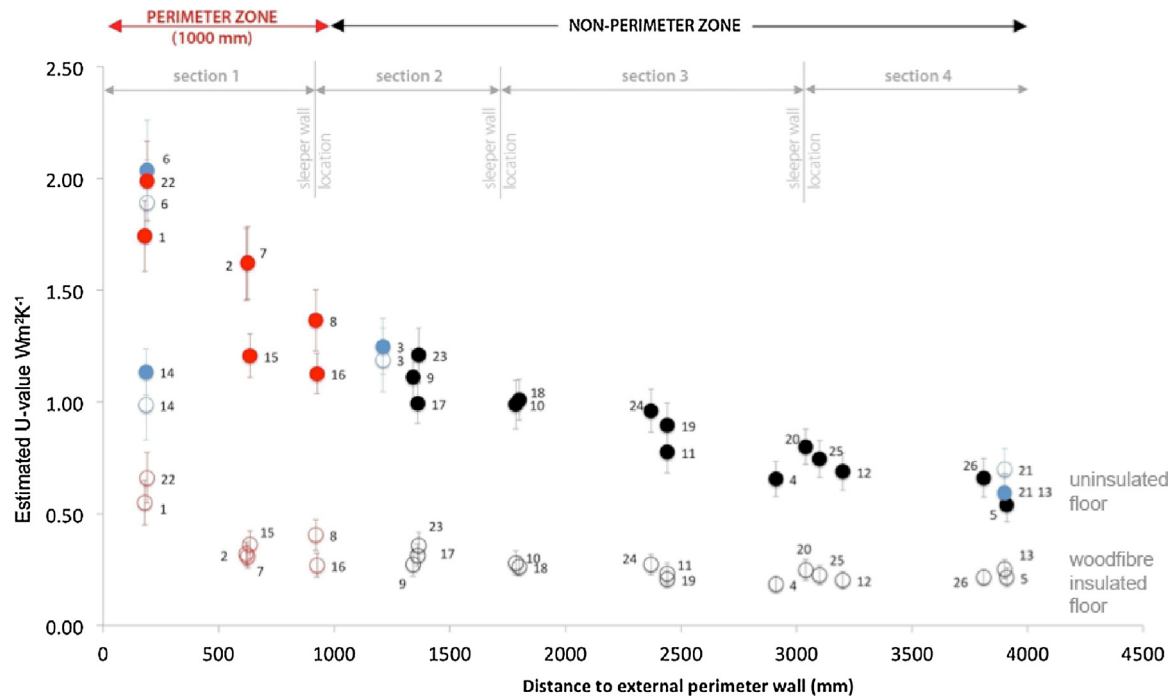
U_p -values (outline data points) as a function of distance to the exposed wall; significant U_p -value reductions are observed after insulation. Red data points are located in the 1000 mm perimeter zone; black-data points are >1000 mm away from the external perimeter wall. Error margins are as per Eq. (4); pre/post insulated point U -values are generally outside the estimated margins of error, although U_p -values in locations 3, 6, 14 and 21 (in blue) are within the margins of errors, likely due to installation quality issues – see 4.3.

Fig. 11. Plots the uninsulated U_p -values (solid data points) compared to woodfibre-insulated U_p -values (outline data points) as a function of distance to the exposed wall; significant U_p -value reductions are observed after insulation. Red data points are located in the 1000 mm perimeter zone; black-data points are > 1000 mm away from the external perimeter wall. Error margins are as per Eq. (4); pre/post insulated point U -values are generally outside the estimated margins of error, although U_p -values in locations 3, 6, 14 and 21 (in blue) are within the margins of errors, likely due to installation quality issues – see 4.3. (For interpretation of the references to colour in this figure legend, the reader is referred to the web version of this article.)

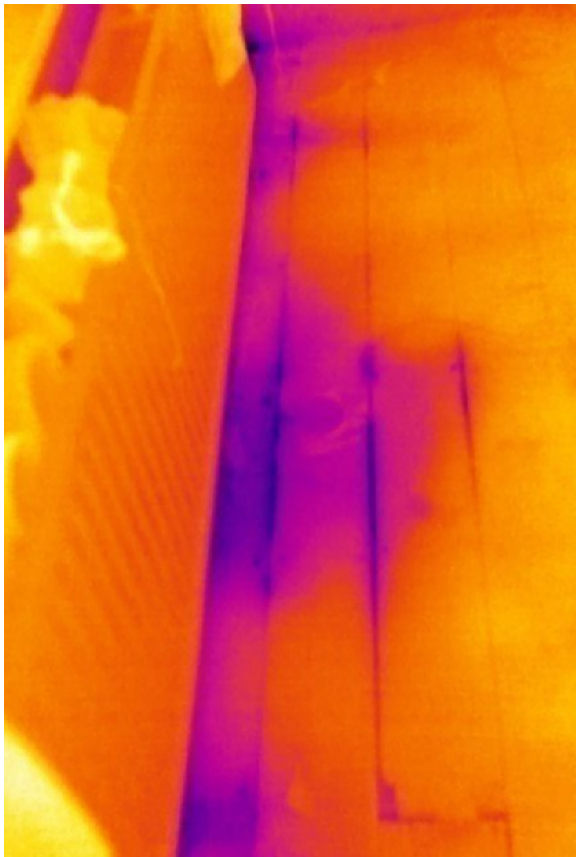
Fig. 12. Shows a thermal image of woodfibre insulated floor and the ineffective fitting of insulation in location 6 along the perimeter.

thermal image Fig. 12. Such installation issues are likely to have contributed to an increased perimeter effect; this might also have occurred in other non-observed locations. Similarly, installation issues were identified in the other outliers (see Table 3): ill-fitting insulation and gaps in floorboards and membrane in Location 3 and a 15–20 mm gap between a bent floorboard and the insulation below in location 21, a likely source of a thermal bypass.
